## Technical Service Bulletin

SUBJECT: REMEDIAL PROCEDURE TO ADDRESS FLASH ARRESTOR

BULLETIN NO.: TSB 2019-01

AFFECTED MODEL(S): **BR-22 PLUS** EXOTHERMIC CUTTING TORCH

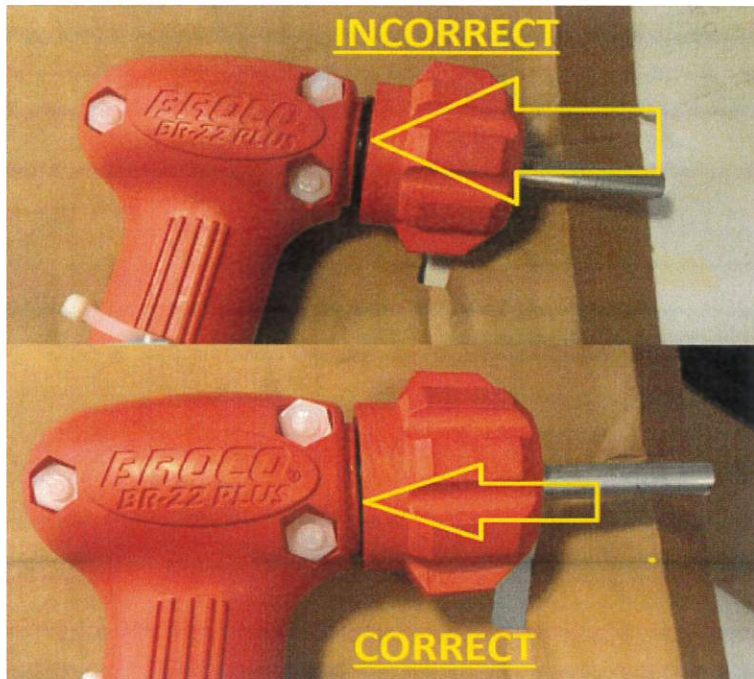
- The pictures below show the correct and incorrect collet nut tightened as it should be. Always use the aluminum test plug (or Broco cutting rod) provided with the torch when tightening to prevent deformation of the collet.

- Check for correct collet seating.

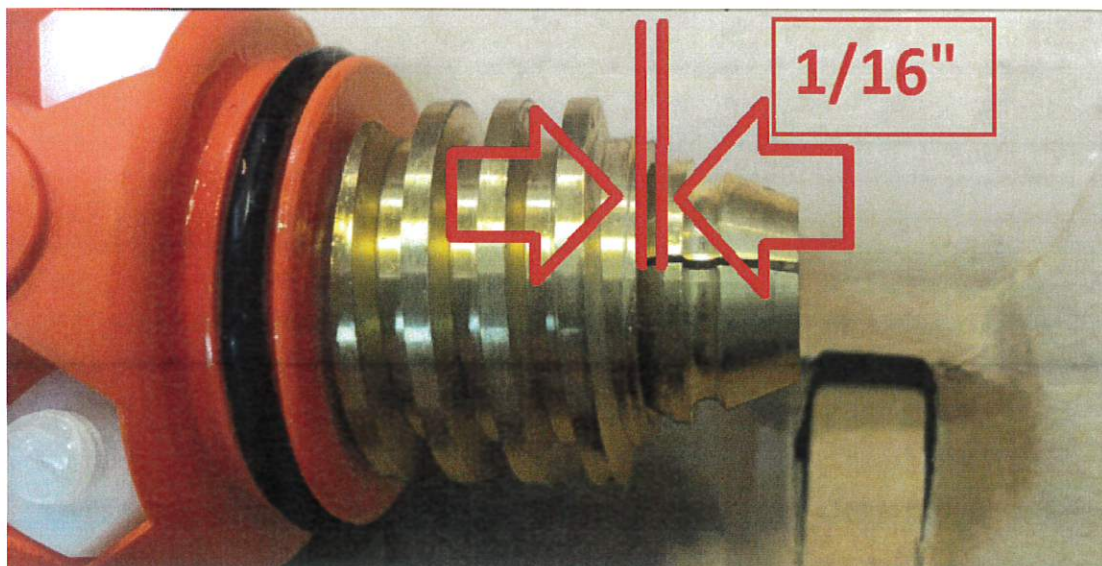
- The collet should be fully seated to the bottom of the collet flange, approximately 1/16 of an inch above the top of the torch head.
